# **The Coach House (Location)**

## ***BUILDING SURVEY***

Prepared by John Gammon

July 2009

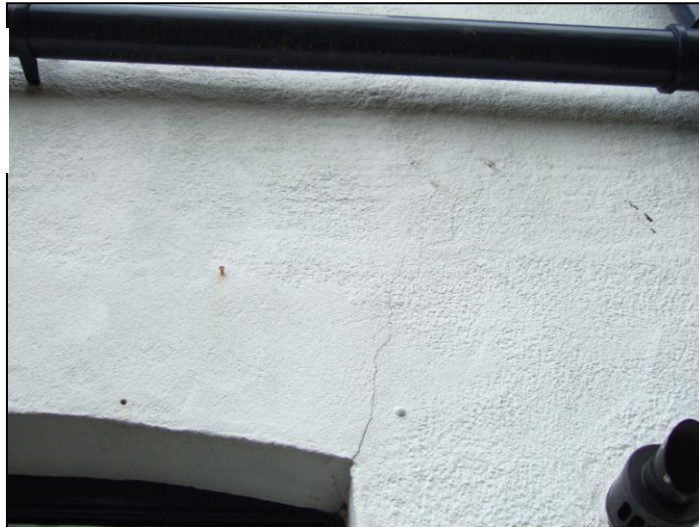
Fig. 5.4

There is some cracking to be noted, rising diagonally from the top right corner of the kitchen window. Though the presence of render can conceal the full extent of cracking, this appears to be some long standing structural movement, and is not a cause for concern at this point.

Crack to Render, Corner  
of Kitchen Window

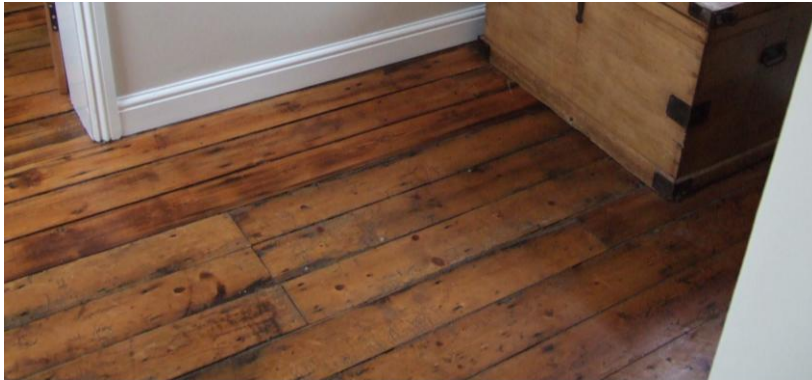
Fig. 5.9

The timber floorboards to the lounge dining room and the bedrooms, bathroom and landings upstairs show evidence of some long standing insect attack notably Common Furniture Beetle (*Anobium punctatum*) to a number of areas, notably the 1<sup>st</sup> landing at the top of the stairs from the kitchen area. There is no frass or evidence of continuing activity, and the structural impact appears minimal. This is common in property of this age, and should not cause concern unless

ongoing or having a significant structural impact. There is some evidence of the fitting of replacement reclaimed boards in place of originals, possibly due to historical insect or fungal attack, or possible due to the various phases of internal alteration that the property has been subjected to.

Long standing evidence  
of insect attack

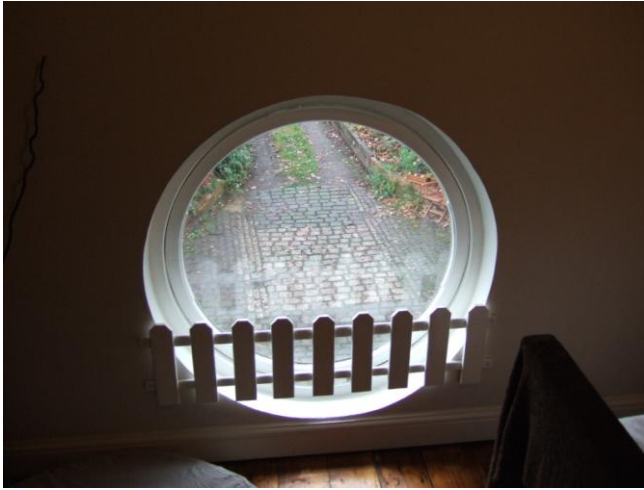
Fig. 5.11

potential security risk. In addition, if replacement was considered, a similar type and construction would probably be required due to the conservation area status of the property.

Round window to 3<sup>rd</sup>  
bedroom

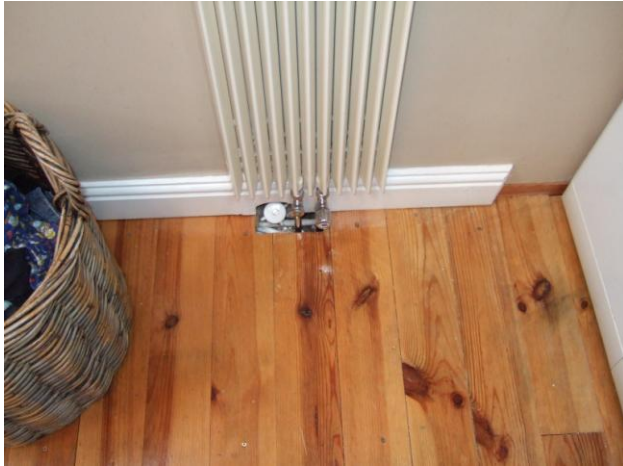
Fig. 6.3

The central heating installation is in good condition, but there is one point to note with the non-standard valve installation to the shower room / utility. This sunken valve arrangement may make future maintenance difficult. As the system uses a combination boiler, there are no hot or cold water storage tanks in the property.

Valve arrangement to  
shower room / utility  
radiator

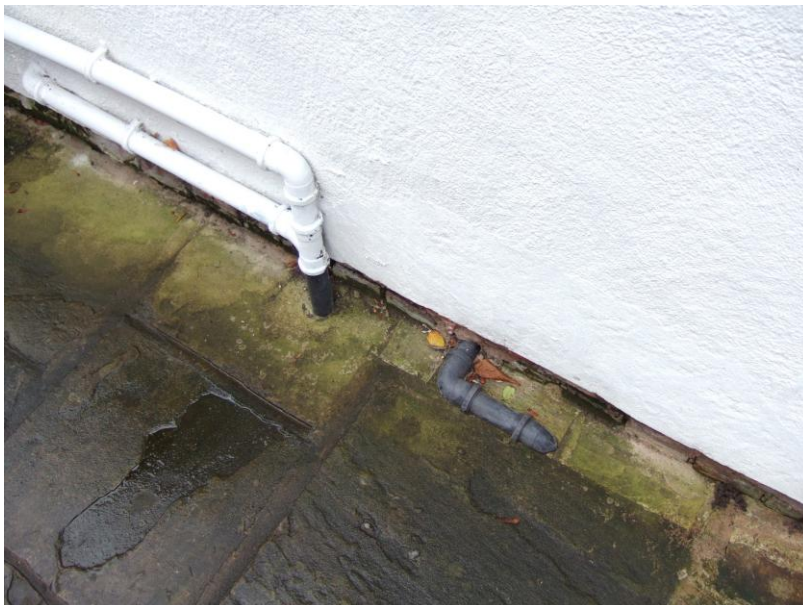
Fig. 6.4

To the right hand elevation of the property on the outside wall to the shower room utility, there is a waste pipe from the shower is half sunk in the paving. This is a poor detail and should be reworked in due course to reduce the vulnerability of this pipe to impact damage.

Waste pipe from shower
